DIREKT

0 7 / 2 0 1 3

## GOOD TO KNOW: THE SANDING DRUM

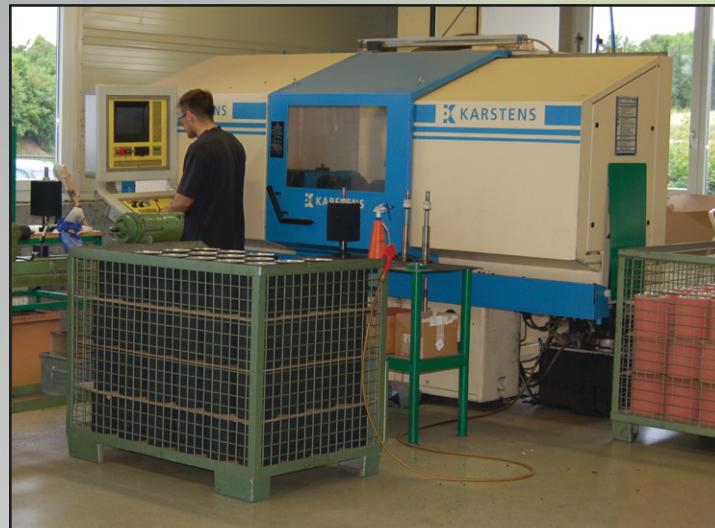
Pic. 1 Production of the LÄGLER® sanding drums

The sanding drum is one of the most important parts of a sanding machine. It transfers the machine's performance to the sand paper and consists of an aluminium-core as well as a layer of rubber adjusted to the sanding process.

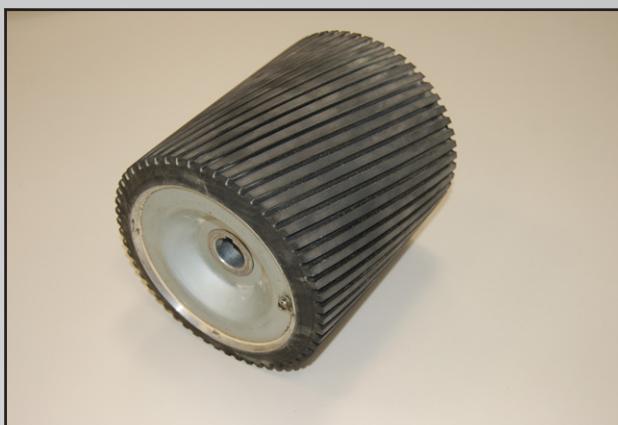
**Pic. 2** Aftermarket / recovered sanding drum

- Aftermarket / recovered sanding drums are not balanced properly and that may cause waves.
- Aftermarket / recovered sanding drums are not the same shape as original LÄGLER® drums. The flat shape causes less pressure per square inch.
- The risk of side cuts is especially high.

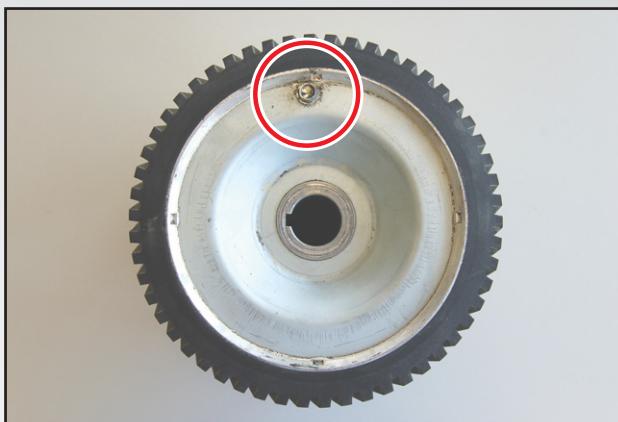
**Pic. 4** Sanding drum body with an old balancing weight

An NON Original sanding drum can usually be recognised by its poor quality rubber layer, used aluminium core and its old balancing weights.

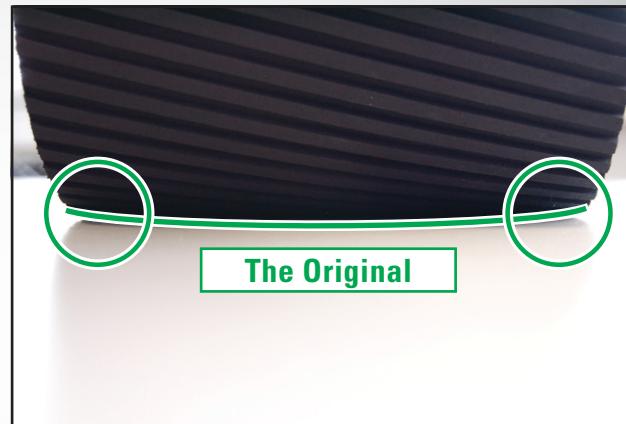
Pic. 5 Shape of a LÄGLER® sanding drum

When looking at a new LÄGLER® sanding drum it is easy to miss that the drum's diameter is larger in the middle than it is at the edges. However, this shape is crucial to the quality of the sanded surface. Contrary to the LÄGLER® sanding drum, NON Original sanding drums have a flat shape.

A wood floor is never even. A **flat sanding drum** will cause side cuts. In order to prevent this, the sanding drum's diameter has to decrease from the middle to the outside – it has to be **shaped like a football** in order to feather at the edges.

The original LÄGLER® sanding drum on the other hand is convex and therefore the edges do not touch the surface allowing for more precise sanding.

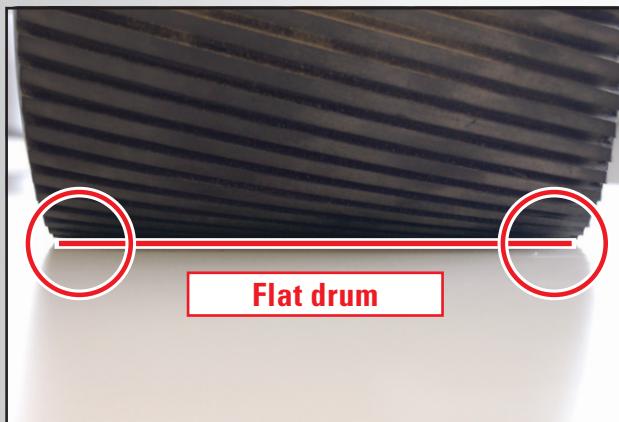
Pic. 6 Flat shape of a recovered sanding drum

If both sanding drums are placed on an even surface, the edges of a NON Original sanding drum will always touch the surface.

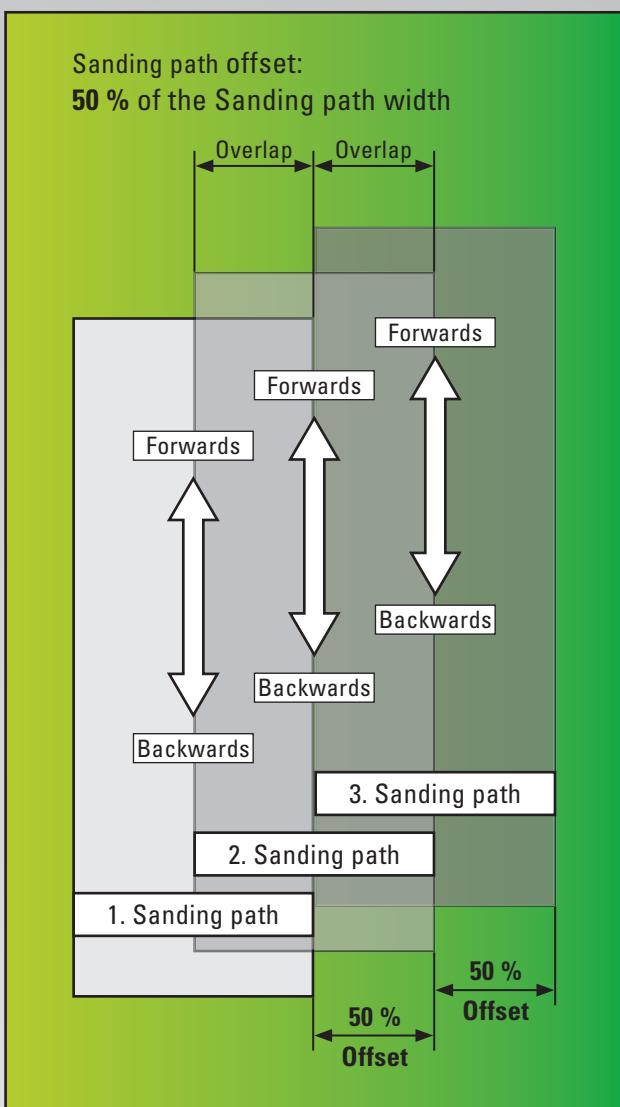
Pic. 8 The ideal Offset is 50 %

You can optimise the overlap by using the ideal offset of **half a sanding drum's width**. Each sanding path is sanded two times.

This way, you will get an even surface.

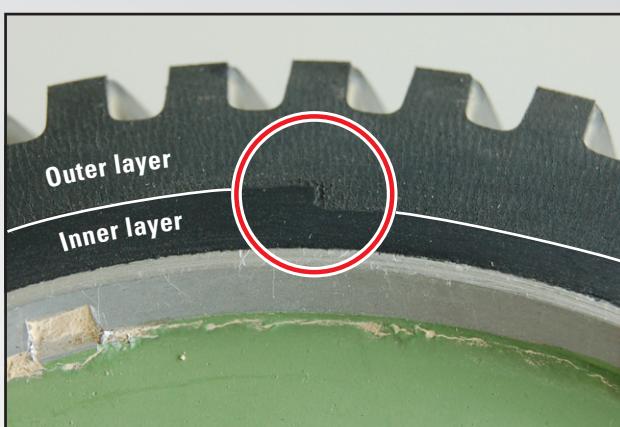
Pic. 9 Rubber layer with overlap (see red circle)

A sanding drum's rubber layers consist of an inner layer that connects to the sanding drum's aluminium core and an outer layer with a custom profile. LÄGLER® applies the inner layer at an even thickness without overlapping in order to prevent vibrations.

The layers of an aftermarket / recovered drum overlap. The increased hardness at this spot causes vibrations and therefore waves.

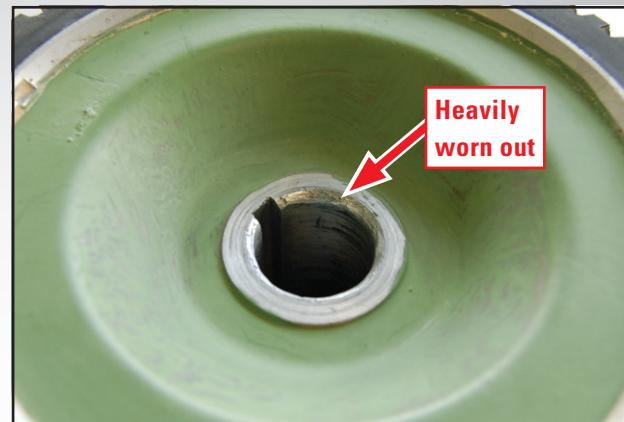
**Pic. 10** Aftermarked / recovered drum with a worn out bore for the sanding shaft

We at LÄGLER® do not reuse old sanding drums, as the bores tend to wear out. When recovering the sanding drum the bore would have to be replaced completely in order to guarantee a balanced drum. This makes recovery too costly. That's why we do **not** recommend that.

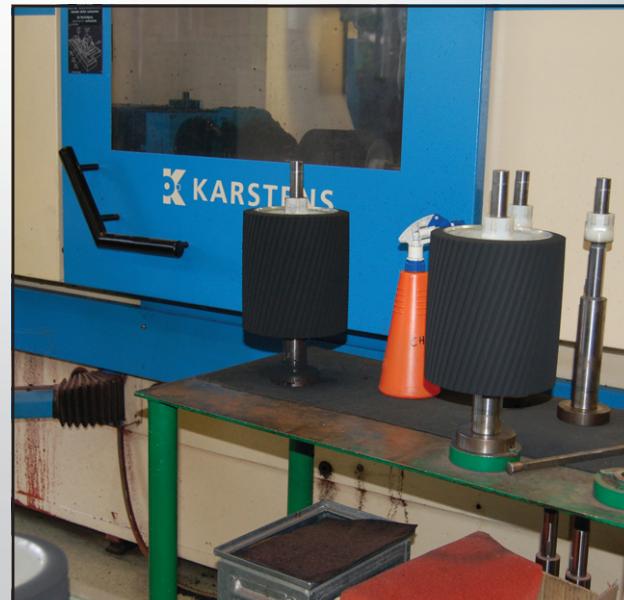
**Pic. 11** LÄGLER® sanding drums before balancing

This is done to guarantee a perfectly round sanding drum as well as perfect sanding results. Special screws are used as balancing weights and placed on the sanding drum's lid.

When recovering a sanding drum, balancing is required due to the newly applied rubber layers. However, the aftermarket / recovered drums on the market that still had the old balancing weights were out of balance.

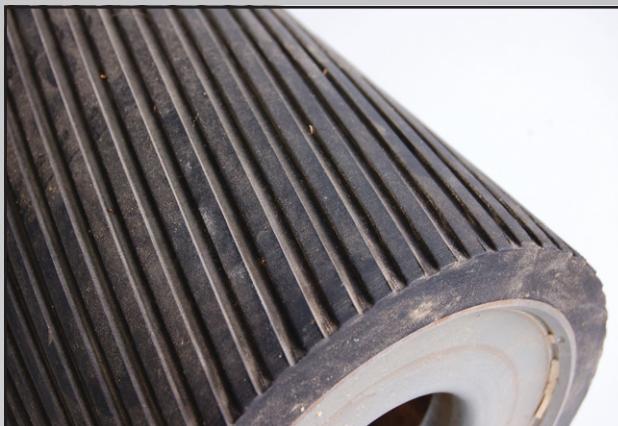
Pic. 12 Worn out sanding drum profile

Due to continuous use of a sanding machine the sanding drum's profile will wear out over time. The sanding drum's shape will flatten. The larger contact area will increase the risk of sanding flaws and will reduce the aggression by up to 20 %.

If you use your sanding machine on a daily basis we recommend that you replace your sanding drum **every four years (do not have them recovered!).**

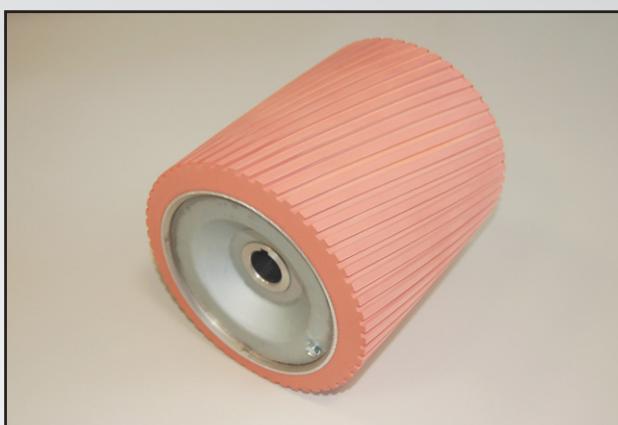
Pic. 14 LÄGLER® sanding drum with a hard rubber coat

The wood surrounding a branch or knot is always harder as the branches' fibres – much like an end grain cut - are standing orthogonally to the wood's surface. Therefore these spots remain elevated after sanding them with a regular sanding drum, which leads to an uneven wood floor.

The best way to sand wood floors with knots, we recommend the use of a sanding drum with a hard and football shaped rubber.
